## **SureShade – Internal Actuator Drive Inspection**

For reference in the event the motor and drive assembly seem to be disengaged from each other due to over-retraction of the actuator. If the actuator bottoms out from over retraction, it is possible with continued retracting of the framework the screw mechanism can be pulled away from the motor engagement. This document describes the steps in disassembling the internal components so a technician can inspect and correct the issue. If the SureShade system is integrated inside a hardtop cavity, the actuator should be removed from the hardtop.

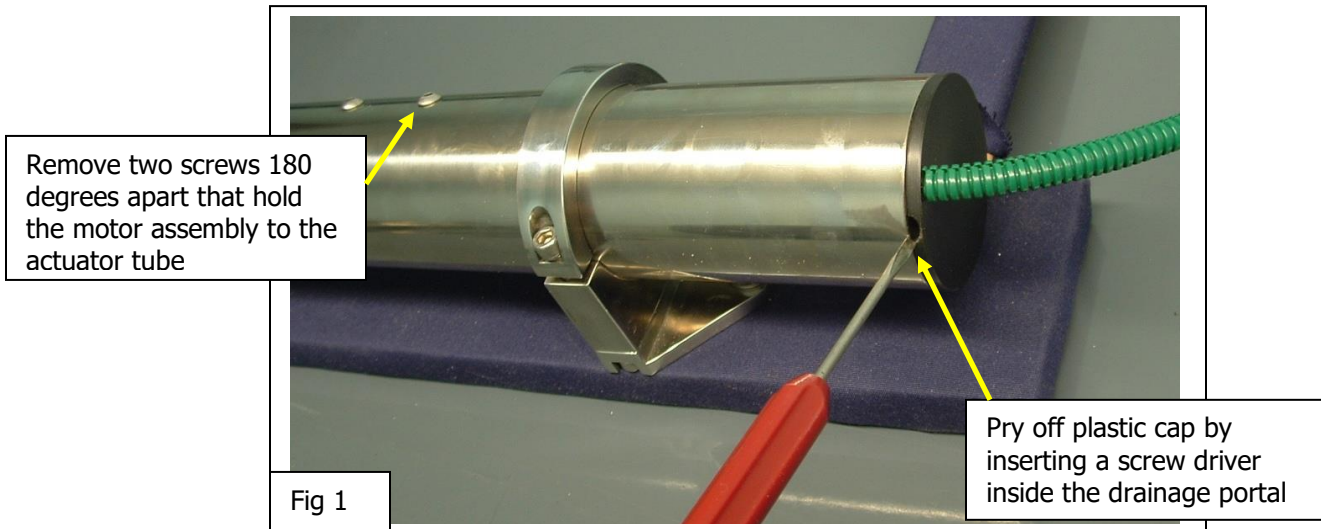
To remove the motor assembly from the actuator's stationary tube, insert a screw driver into the drainage portal and pry off the plastic cap. Then remove the two screws (180 degrees apart) that hold the motor assembly in place (Fig 1).

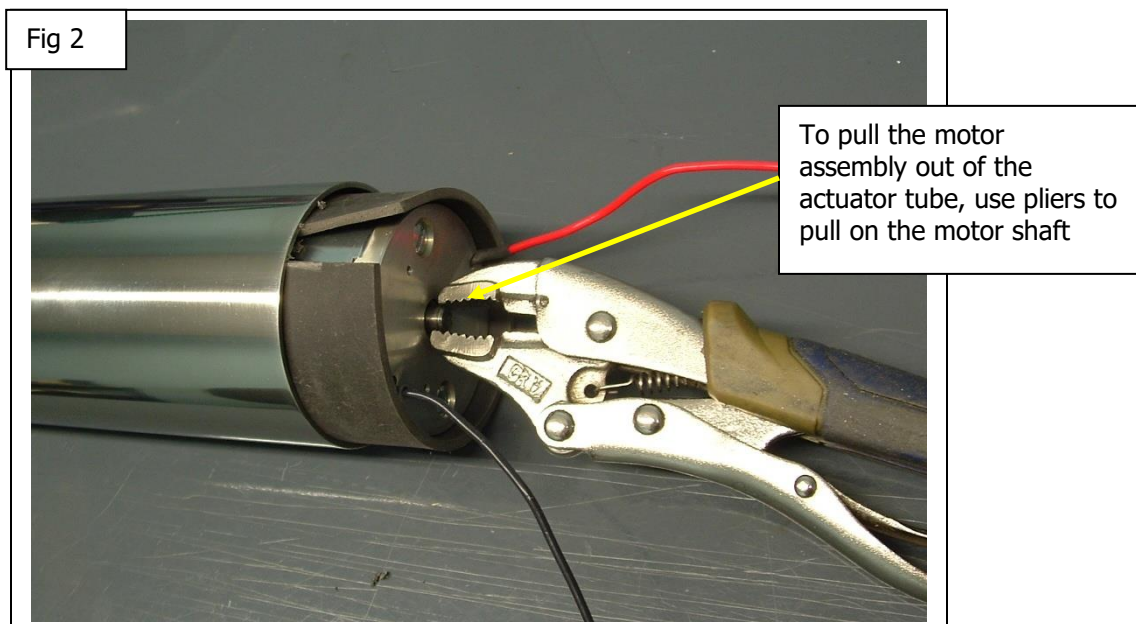
Grab the back end of the motor shaft with pliers to pull the motor assembly out from the actuator tube (Fig 2).

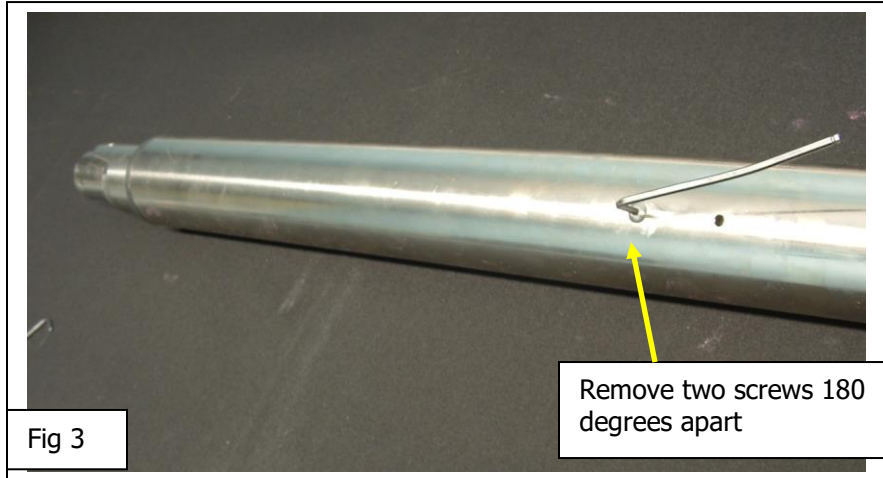
To remove the drive from the actuator tube, remove the two screws (180 degrees apart) as shown in Fig 3 and remove the set screw that holds the plastic sleeve in place (Fig 4).

Reassemble the drive into the actuator and secure mounting screws (Fig 3 on Page 2) and set screw for the plastic sleeve (Fig 4 on Page 2). Then reinstall the motor assembly with the below instructions (Fig 8 thru 13).

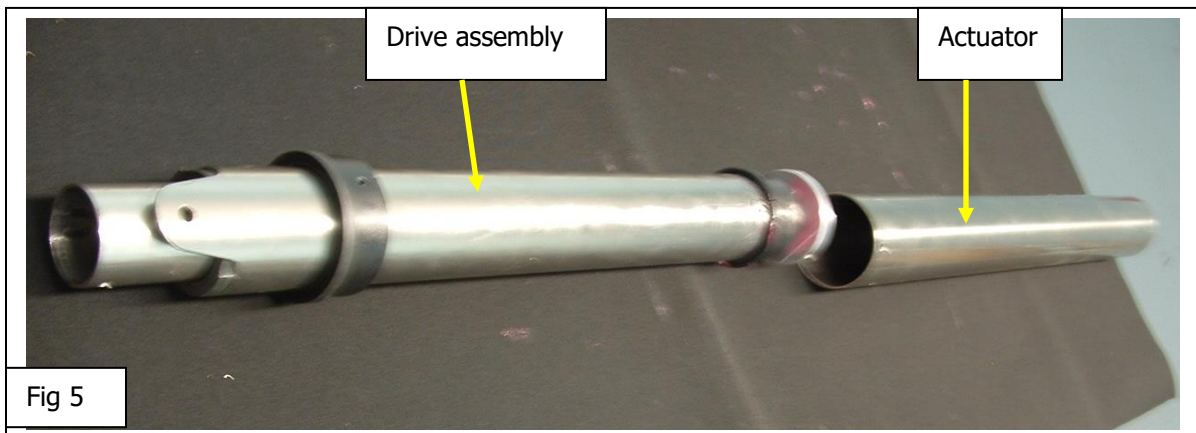
With the screws removed, you can pull the entire drive from the actuator tube (Fig 5).

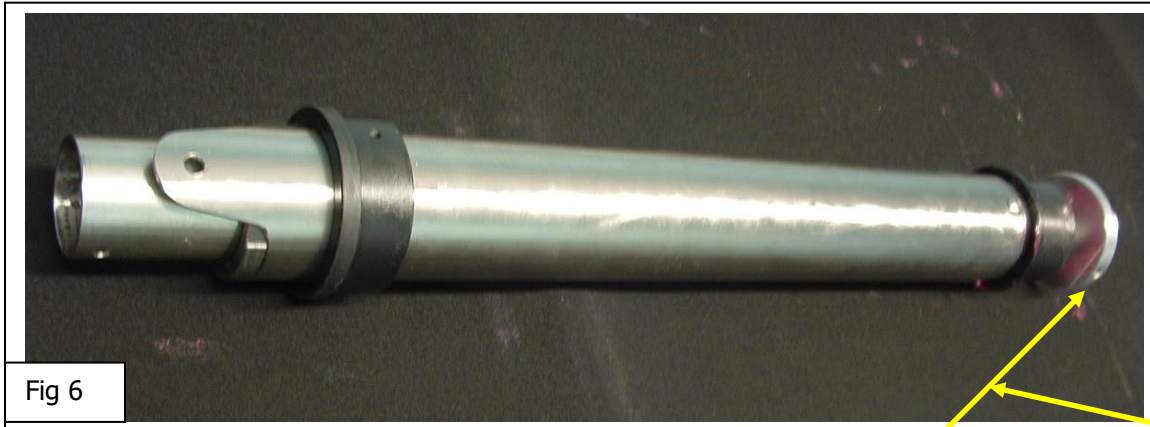
Inspect the end of the drive system to see if the lead screw has been pulled from the locking collar shown in Fig 6 creating a disengagement from the motor.

Inspect the end of the drive assembly

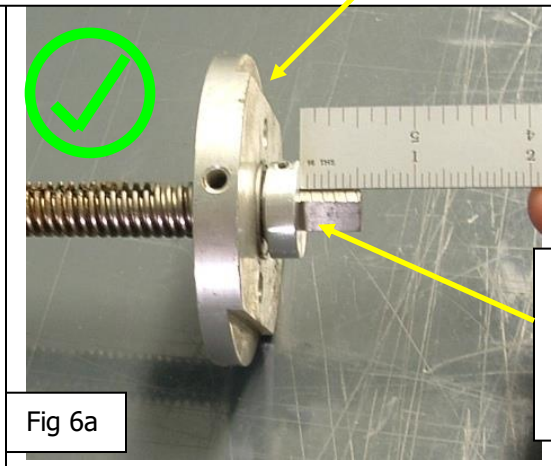
Fig 6a

The lead screw should stick out approximately 1/2 from the shaft collar

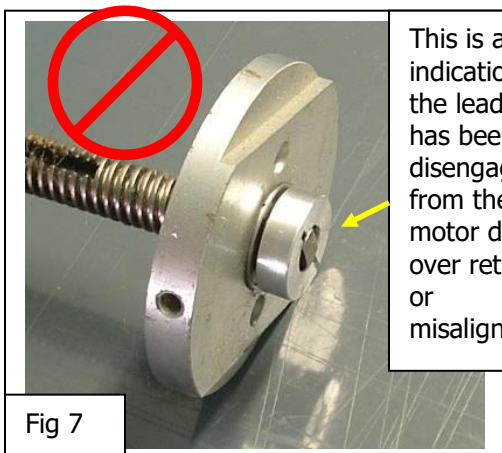
Fig 7

If the lead screw is flush with the collar as shown in Fig 7, the screw has been pulled from engagement to the motor due to over retraction. In this situation you will need to remove the collar from the shaft (Fig 7a) and press the lead screw mount along with the bearing down to its proper position and then secure the collar back to the shaft.

This is an indication that the lead screw has been disengaged from the motor due to over retraction or misalignment.

To correct the issue, remove the collar and press the mount along with the bearing down to the shoulder on the lead screw. Then resecure the collar.

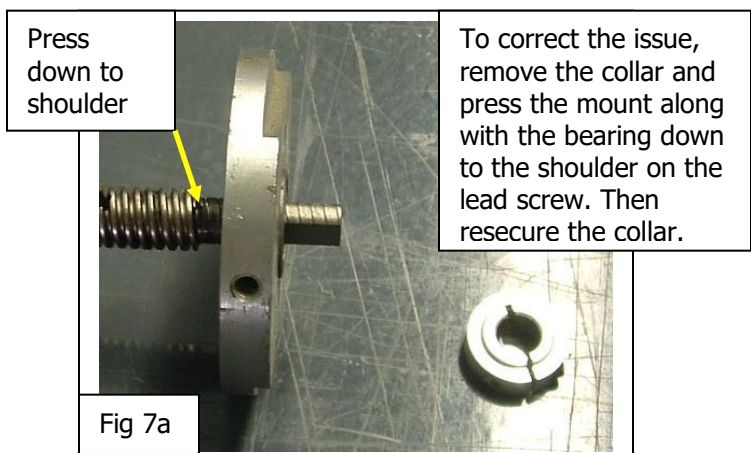
Fig 7a

Press down to shoulder

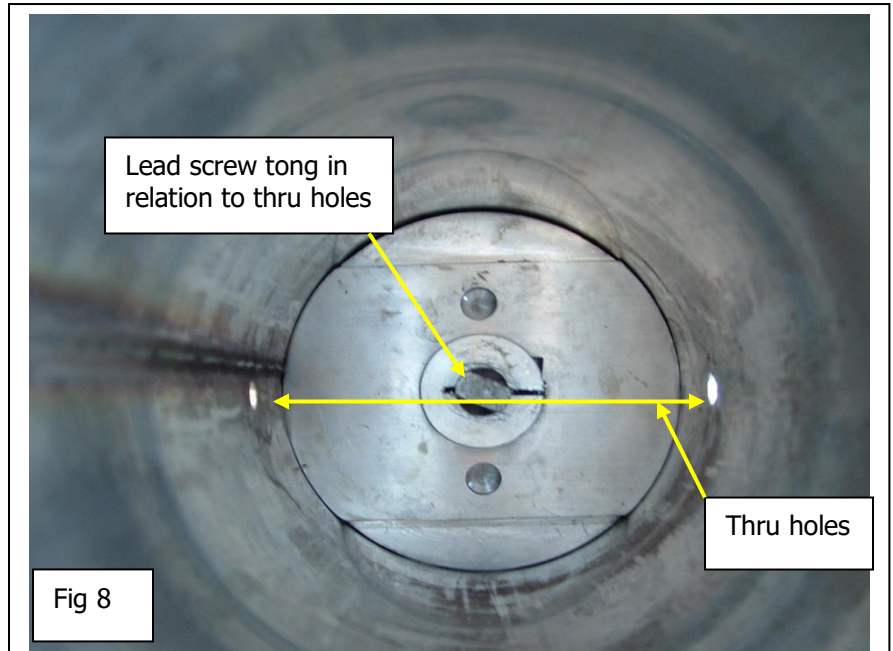
Fig 8 – Look into the actuator tube to determine the position of the lead screw tong in relation to the position of the thru holes for securing the motor to the tube.

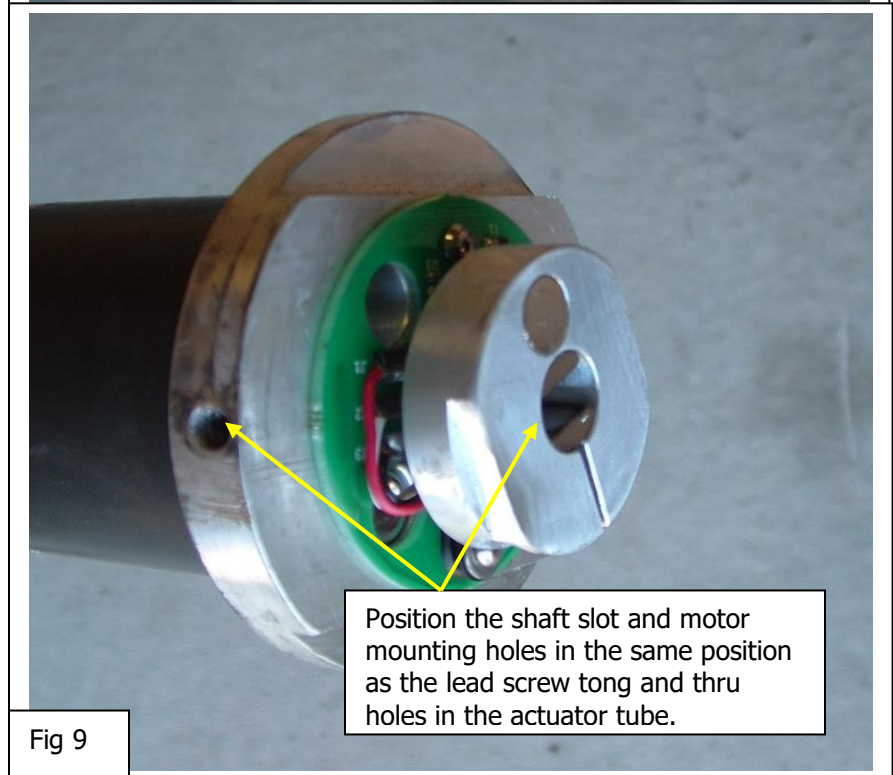
Fig 9 – Rotate the motor shaft slot to line up with the lead screw tong in relation to the position of the thru holes.

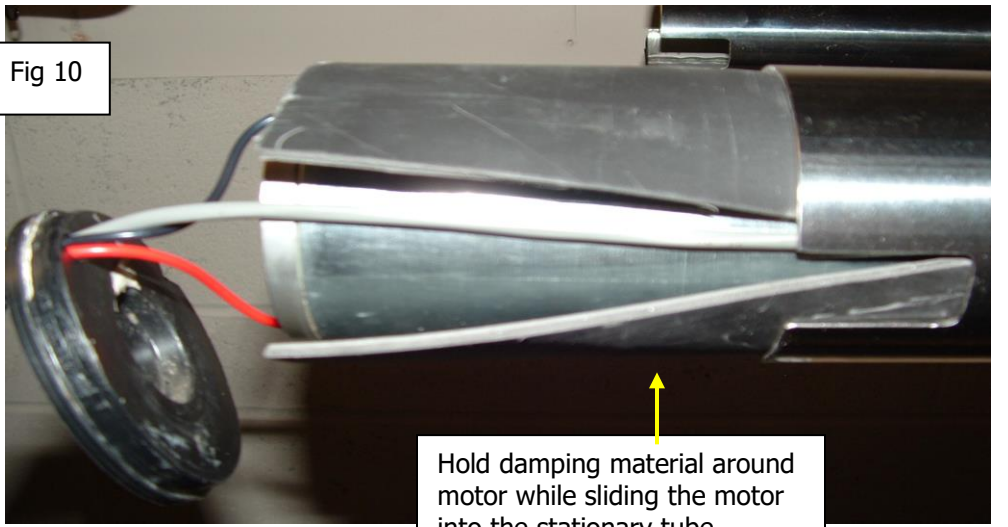
Fig 10 – Wrap damping material around motor. Slide the motor assembly with the damping material around the motor into the actuator tube until motor is engaged with the lead screw and mounting holes line up with thru holes.

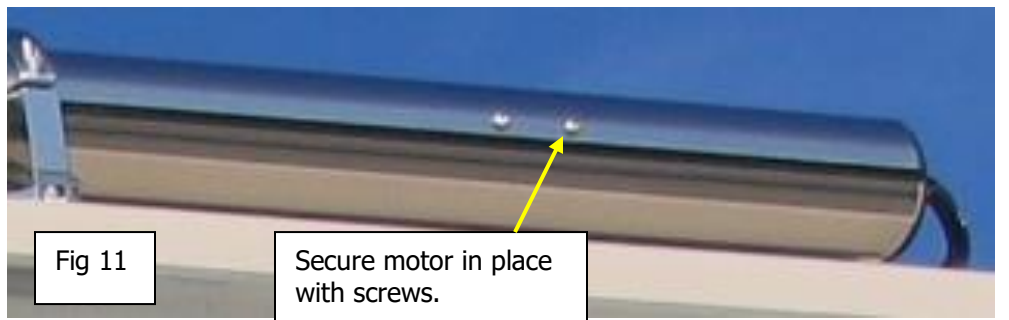
Fig 11 – Secure motor in place with screws.

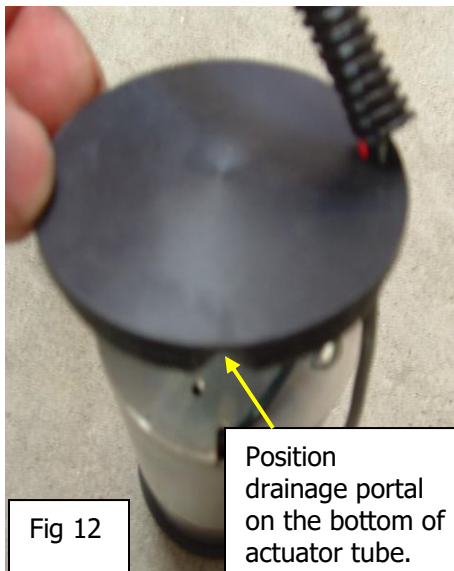
Fig 12 – When positioning the end cap on the end of the tube, place drainage portal at the bottom.

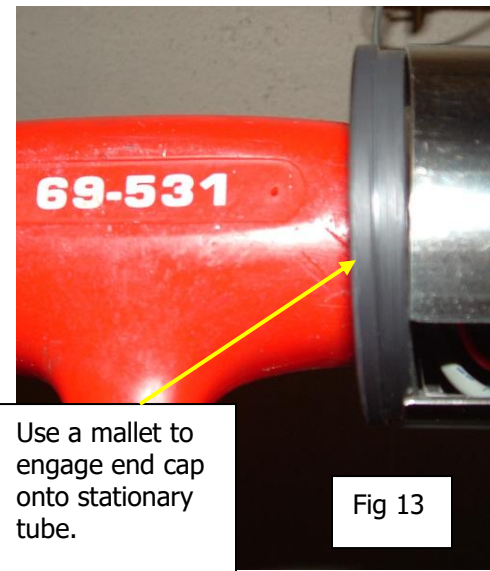
Fig 13 – Use a mallet to hit and secure the end cap into the stationary tube.

Use a mallet to engage end cap onto stationary tube.

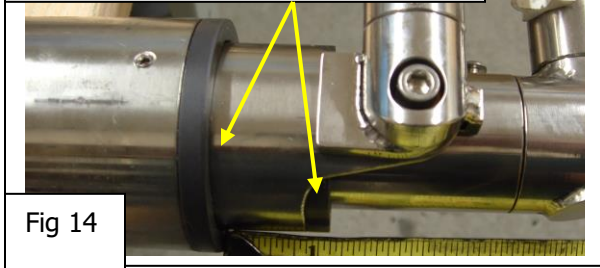
Fig 14

When fully retracted, this dimension should be 1 1/8" from the face of each black plastic sleeve.

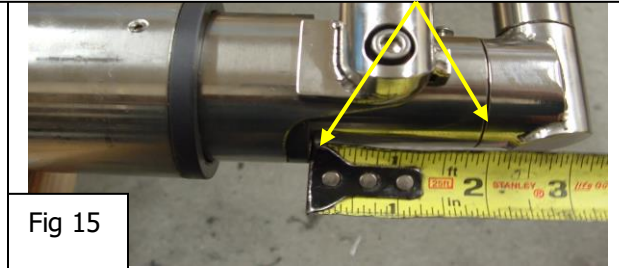
Fig 15

When fully retracted, this dimension should be 1 7/8" from the end of the tube (not including the crossbar insert) to the face of the black plastic sleeve.

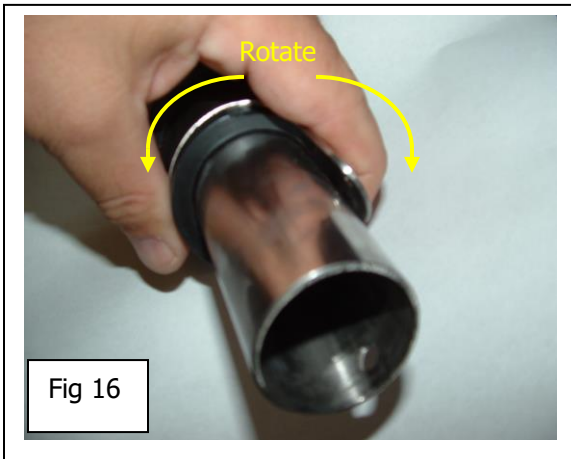
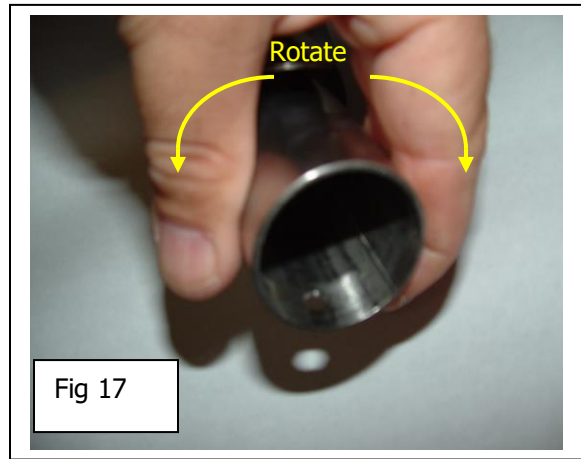
With the crossbars disconnected, adjust the tubes by turning off the power to the unit and rotate the tubes to match each other in extension. Rotating the tubes clockwise will screw the tube into the stationary tube (reducing the length) and counterclockwise rotation will screw the tube out of the stationary tube (increasing the length). Once both actuators are at the same length, reassemble the crossbars and power.
